DELAWARE RIVER BASIN  
HARMONY BROOK, MORRIS COUNTY  
NEW JERSEY

# MORRISTOWN RESERVOIR DAM

## NJ 00352

### PHASE 1 INSPECTION REPORT NATIONAL DAM SAFETY PROGRAM

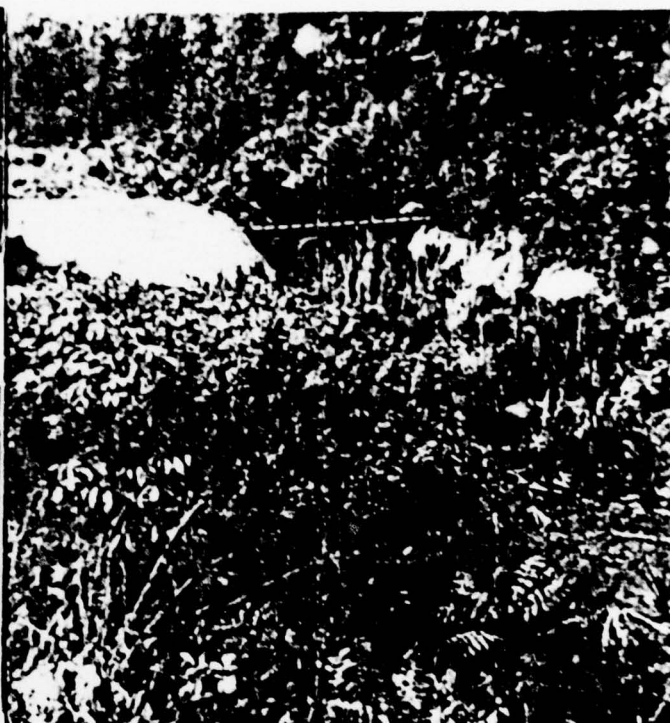
SWALE BEHIND SECONDARY DIKE

- UNDER
- UNDER
- ① Seal the area around the upstream apron of the spillway to prevent leakage under the spillway.
  - ② Riprap the face of the secondary dike along its entire length.
  3. ✓ Grub out and remove growth from the swale behind the secondary dike and the joints within the outlet flume.

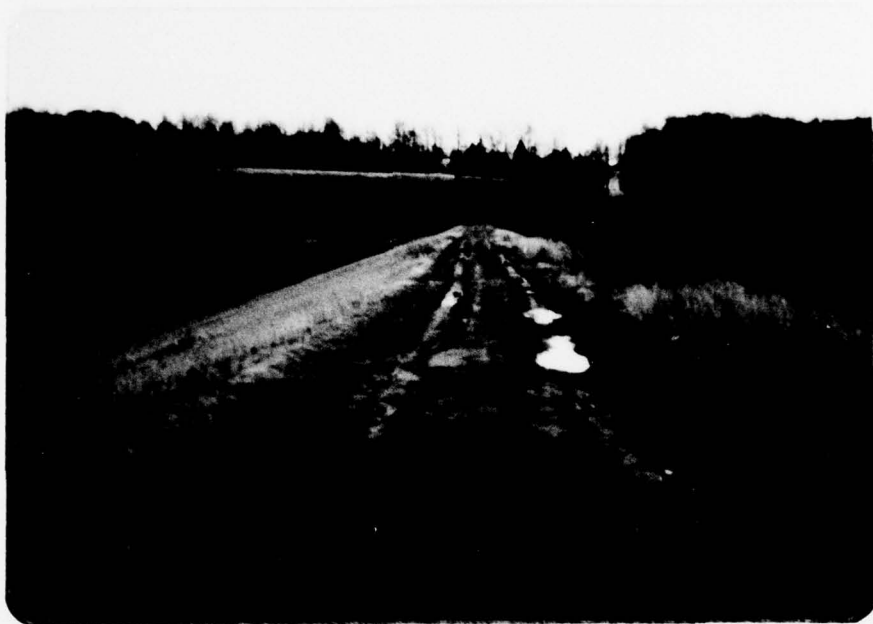
Crest of earthfill dam. Note sags  
in crest.

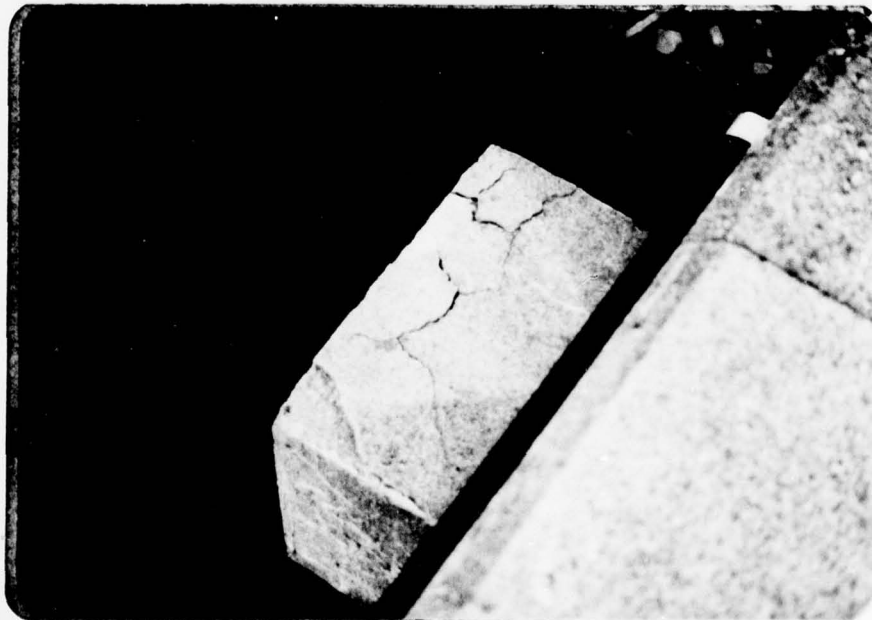
Pier supporting footbridge.  
Note: deteriorated concrete.

13. Repair the spalled and cracked concrete at the spillway, and the gatehouse structure and footbridge. This should be done in the near future.
14. The spillway capacity as determined by CE Screening criteria is inadequate. The actual capacity of the spillway should be determined using more precise and sophisticated methods and procedures. If necessary steps should be taken to increase the spillway capacity. The need for and type of mitigating measures should be determined. Around the clock surveillance during periods of unusually heavy precipitation should be provided, and a warning system established. This should be done soon.
